Analysis of Brownfield Cleanup Alternatives

Former Holy Trinity Convent and School
201 North Convent Street
Trinidad, Colorado 81082

January 5, 2024

Stantec Consulting Services Inc.
601 SW 2nd Avenue Suite 1400
Portland, OR 97204

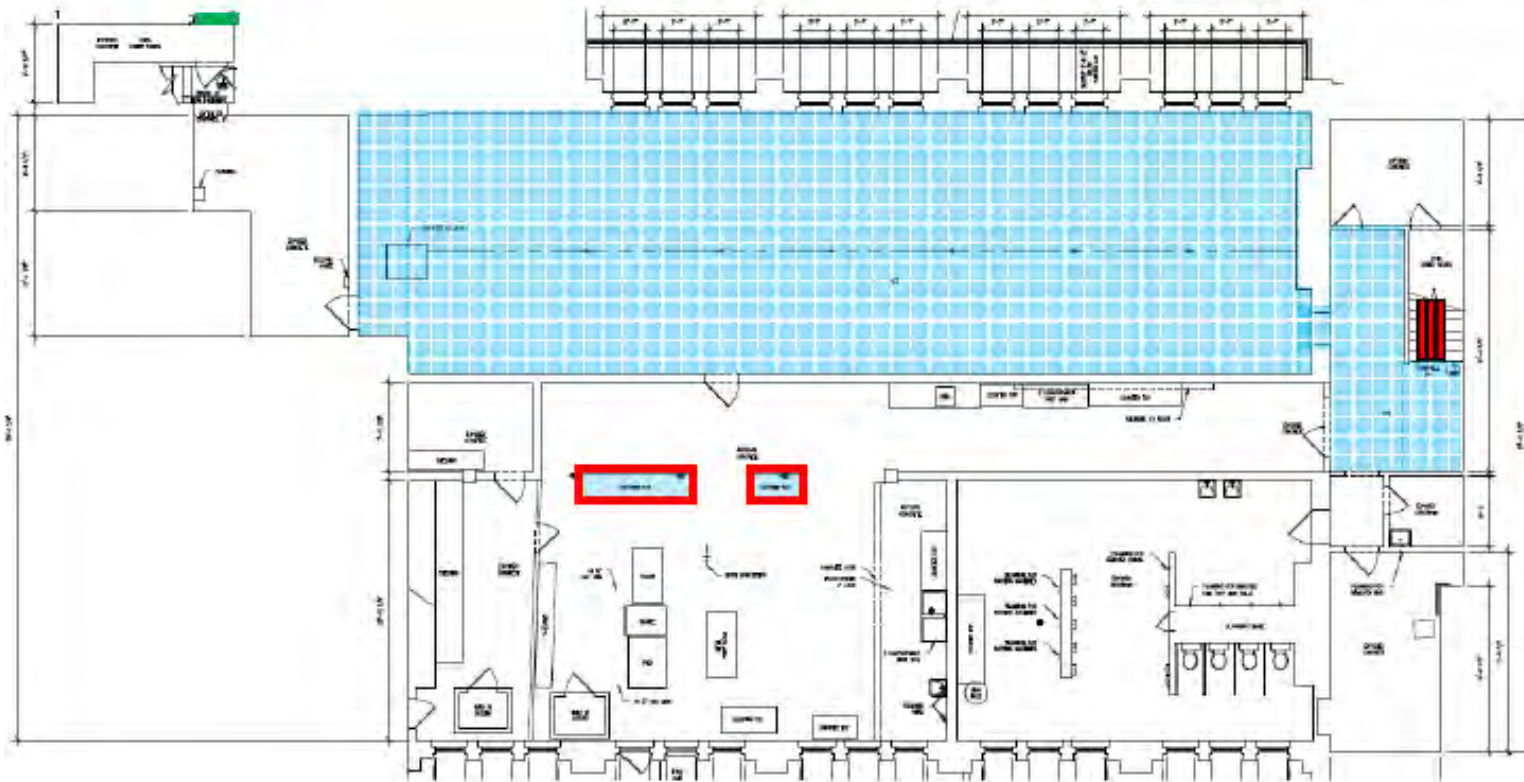
FIGURE 4 - SCHOOL BUILDING BASEMENT

Stair tread & tread mastic between basement & 1st floor

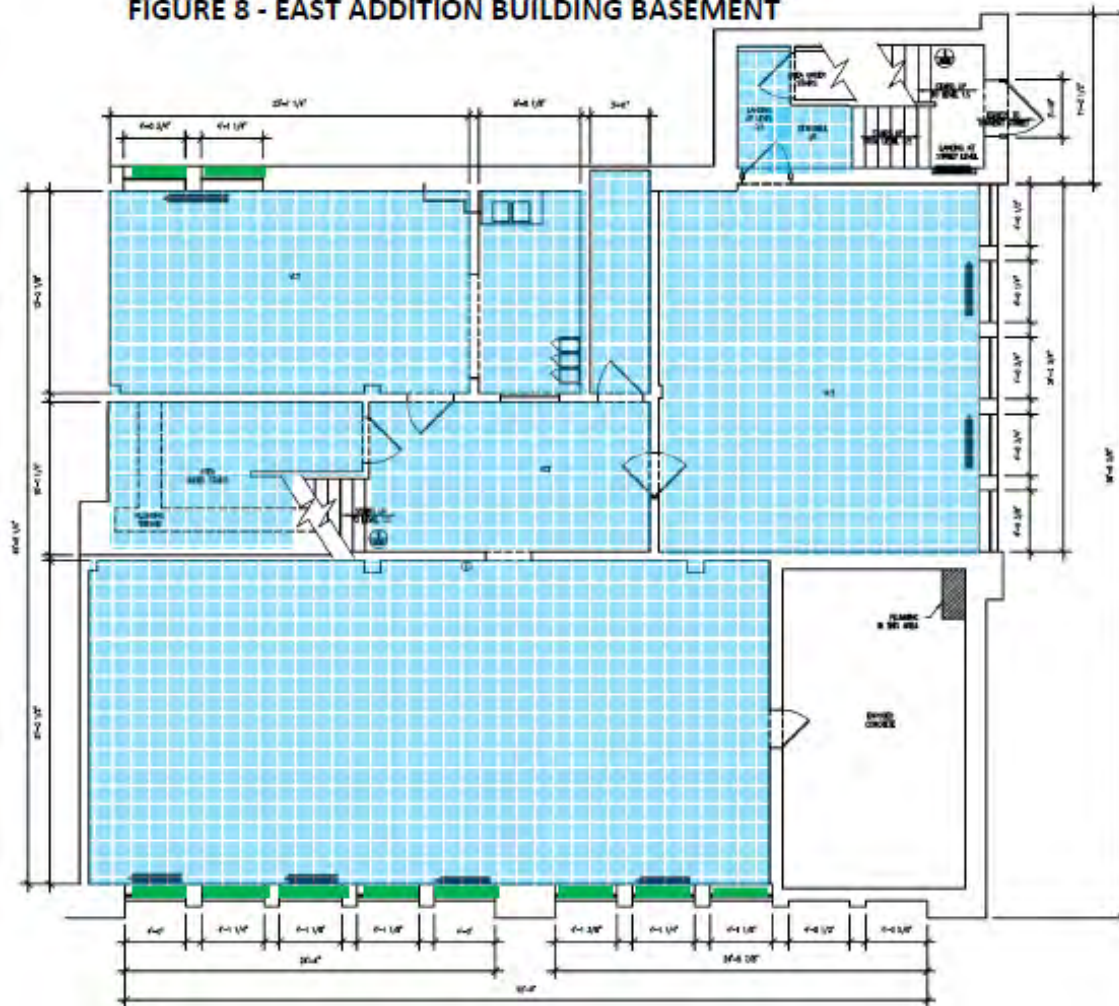
FIGURE 8 - EAST ADDITION BUILDING BASEMENT

- Floor tile & Mastic
- Window glazing compound
